# Manhole Inspection Summary

Manhole # S23QQ1004MH

Insp Date: **12/4/06 10:50 AM**

**Location** Address: **222 HILLSIDE RD**

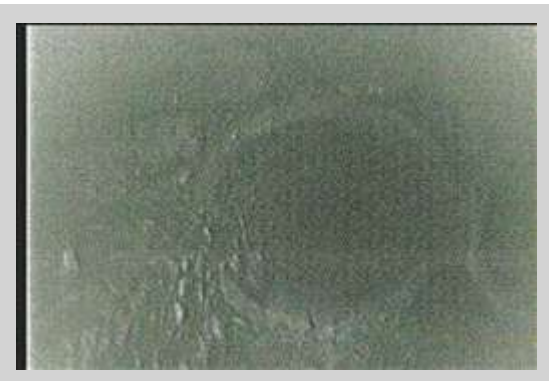
### 6 in. Circular Gravity Sewer Pipe In @ 6 O'Clock

Deposits: ☒ **None** ☐ Mud ☐ Sludge ☐ Debris ☐ Grease

Infiltration: **None** Pipe Seal Cond: **Unknown**

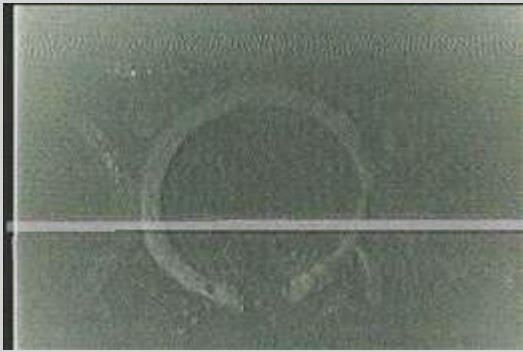
### 6 in. Circular Gravity Sewer

Infiltration: **None**
